Progress Report I  
Heat Treatment of Chromium Plate  
on Steel

Object

To determine maximum effects of very high temperature heat treatment of chromium plated steel

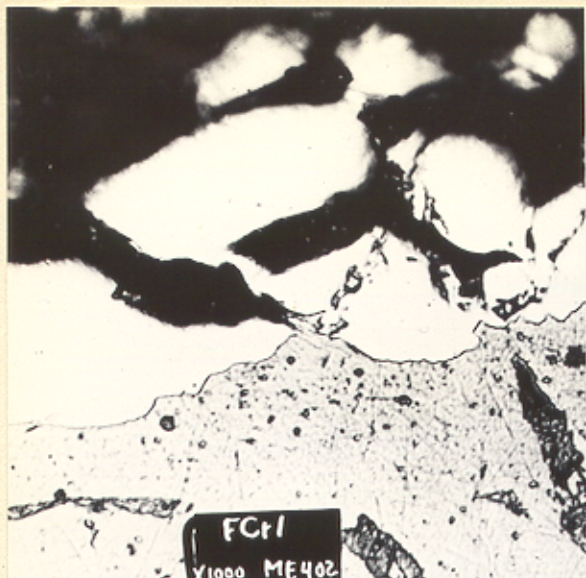
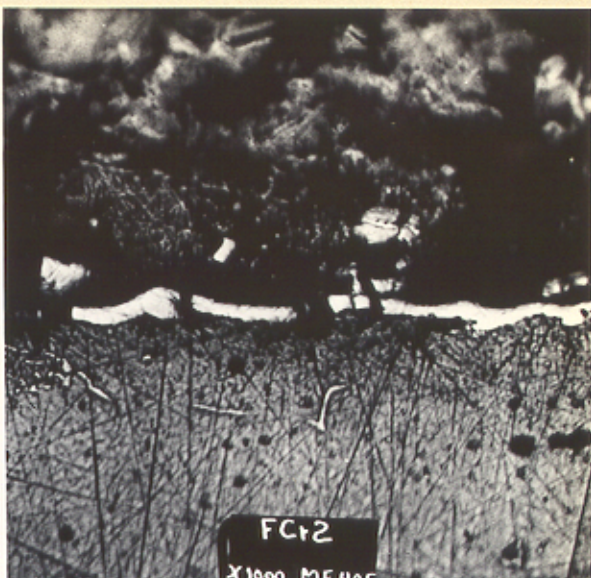
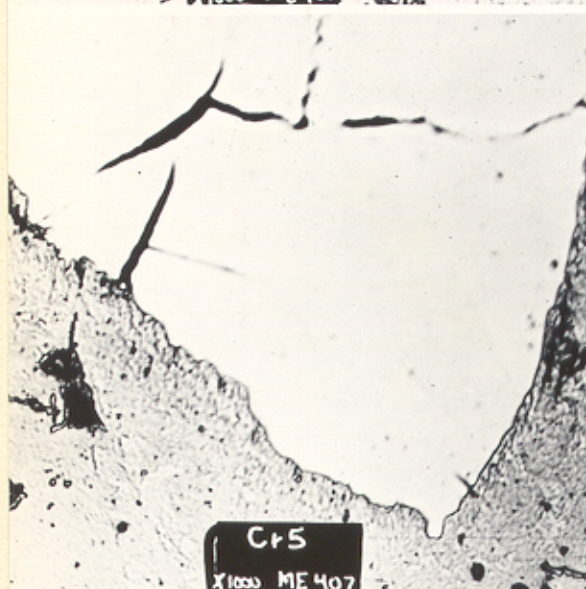
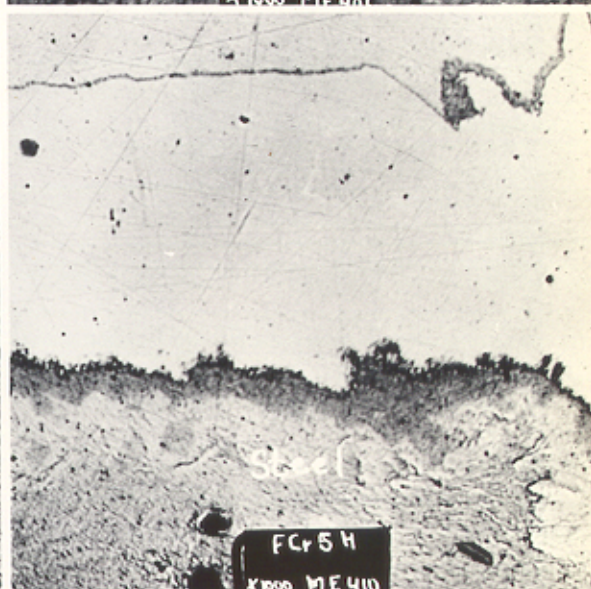
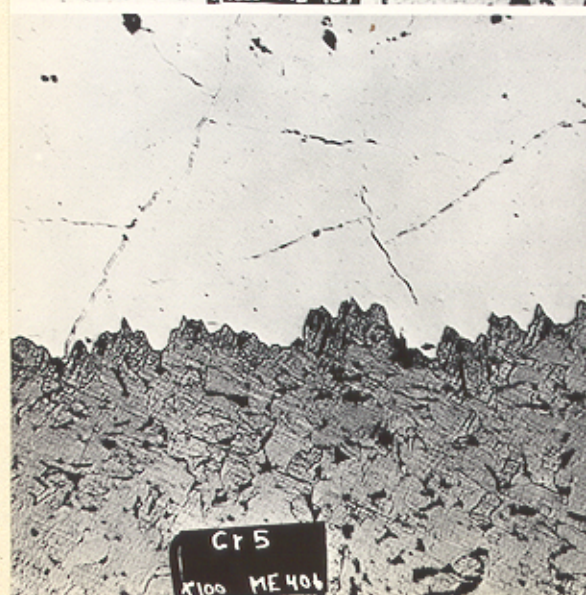
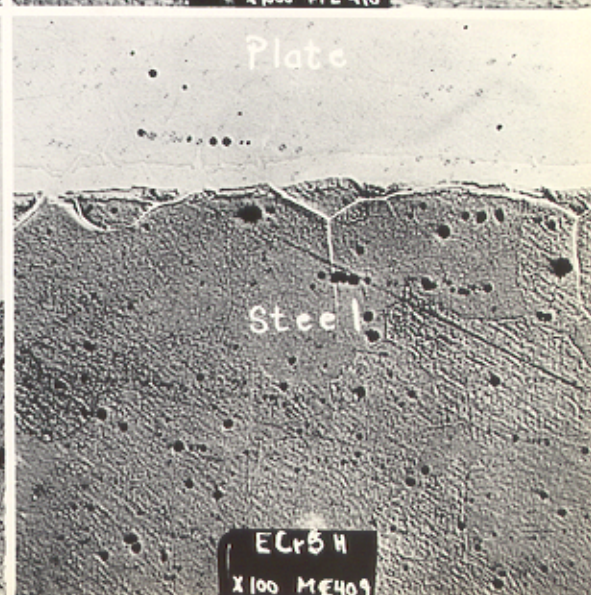
## Chromium Plate on Steel

Steel on bottom; mounting medium on top; Cr plate in middle

### FCr1 X1000 Nital Etch ME402

34.0 oz/gal. chromic acid  
4 oz/gal. trivalent Cr  
3.4 oz/gal. sulfate  
3.8 v; 1 amp/sq.in;  
102/104°F; 1 hour  
Coating: 0.0008" thick,  
cracked, steel exposed.

### FCr2 X1000 Unetched ME405

34.0 oz/gal. chromic acid  
4 oz/gal. trivalent Cr  
3.4 oz/gal. sulfate  
7 v; 3 amp/sq.in;  
102/108°F; 1 1/2 hrs.  
Coating: 0.0001" thick,  
cracked, steel exposed.

Steel on bottom: Cr plate on top

### FCr5 X1000 Nital Etch ME407

33.4 oz/gal. chromic acid  
.4 oz/gal. trivalent Cr  
.4 oz/gal. sulfate  
5.6 v; 3 amp/sq.in;  
108/118°F; 10 3/4 hrs.  
Coating: 0.008" thick, cracked,  
cracks penetrated to  
steel base.

### FCr5H X1000 Unetched ME410

Same as FCr5 only heated  
to 1150°C, 8 hrs, furnace  
cooled. Steel diffused into  
Cr and Cr diffused into steel.  
Some old cracks oxidized.  
Diffusion process sealed  
cracks which penetrated as  
far as steel before diffusion.

### FCr5 X100 Nital Etch ME406

### FCr5H X100 Unetched ME409

Figure 2 shows the microstructure of chrome plated steel before and after heat treatment. Before heat treatment, the plate is full of cracks which reach the base metal, but after heat treatment these cracks are absent. Nital etching does not enhance the evidence of the existence of an alloy between steel and chromium after heat treatment over that in the unetched condition. But etching with  $\text{FeCl}_3$  does reveal the existence of an alloy very plainly, as shown in Figure 3. The hardness as revealed by Bierbaum's microcharacter is also shown. The hardness of Cr plate is lowered from Vicker's Brinell 724 to 139 by diffusion heat treatment. Study revealed the presence of numerous cracks around the Vicker's impression on the hard Chromium plate, and the absence

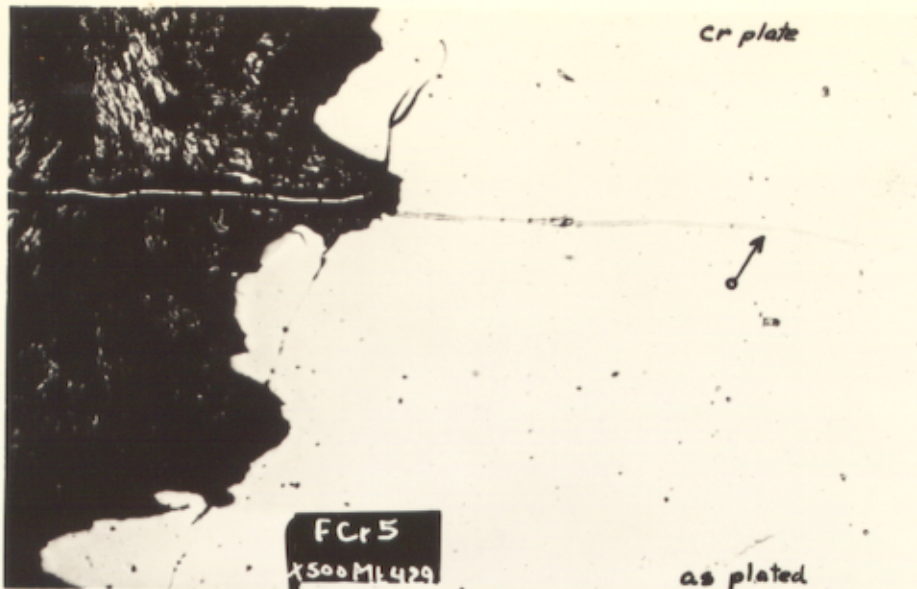
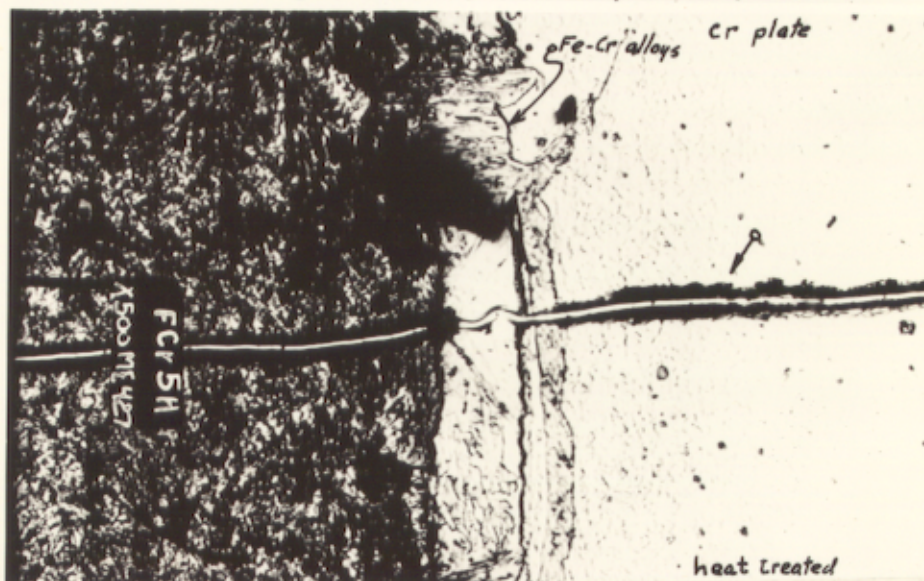
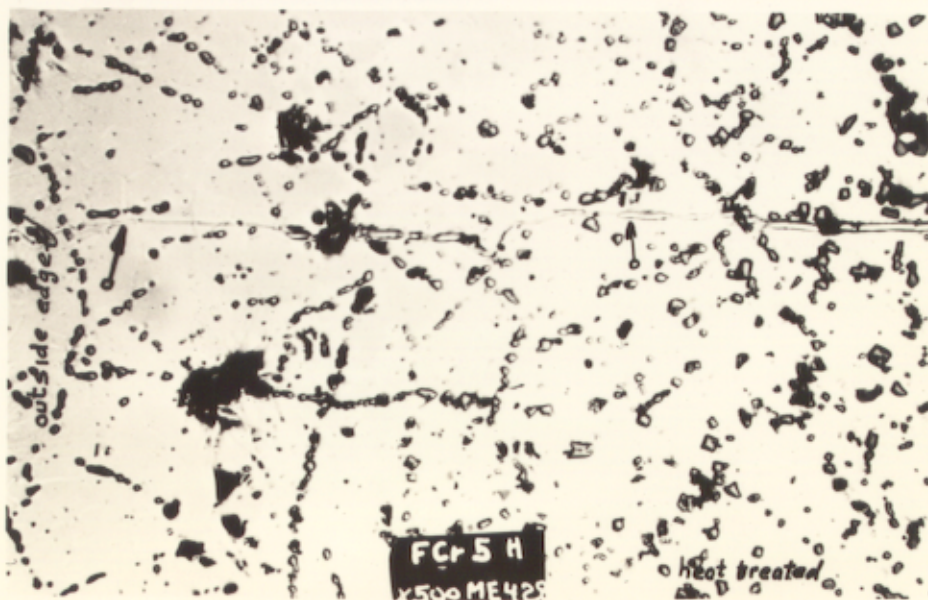
Fig. 3

Scratch hardness of Cr Plate on Steel. Bierbaum Microcharacter 3 g. load.  $\text{FeCl}_3$  etch X500.

Top FCr5 (left) steel base: Vickers Hardness, 10 Kg, 135, (right) Cr plate: Vickers Hardness, 10 Kg, 724

Middle FCr5H, heat treated Cr plate 1150°C, 8 hrs, Furnace cooled. (left) steel base: Vickers Hardness, 10 Kg, 131, (right) Cr plate: Vickers Hardness 139, (middle), hard layer of Fe-Cr alloys.

Bottom Outside edge of FCr5H (left) Oxidized Cr plate at surface is hard. (right) Cr plate further from surface is softer.

of these cracks around the Vicker's impression in the heat-treated and softened Chromium plate. This may be taken as an indication of the improvement in ductility of the plate due to heat treatment.

An interesting observation is shown on the bottom print of Figure 3, (ME 428). The surface of the Chromium plate was oxidized: Grain boundaries and old crack lines are filled with a dove gray constituent taken to be an oxide. This must have formed a solid solution with the Chromium for the extreme outside edge is very hard.
